**SERVICE BULLETIN**  
**NO:99010-r1**

MODELS : TX-DS575

SUBJECT : Noise is heard from "VOLUME MIN" to "VOLUME 1".

**Title:** TX-DS575

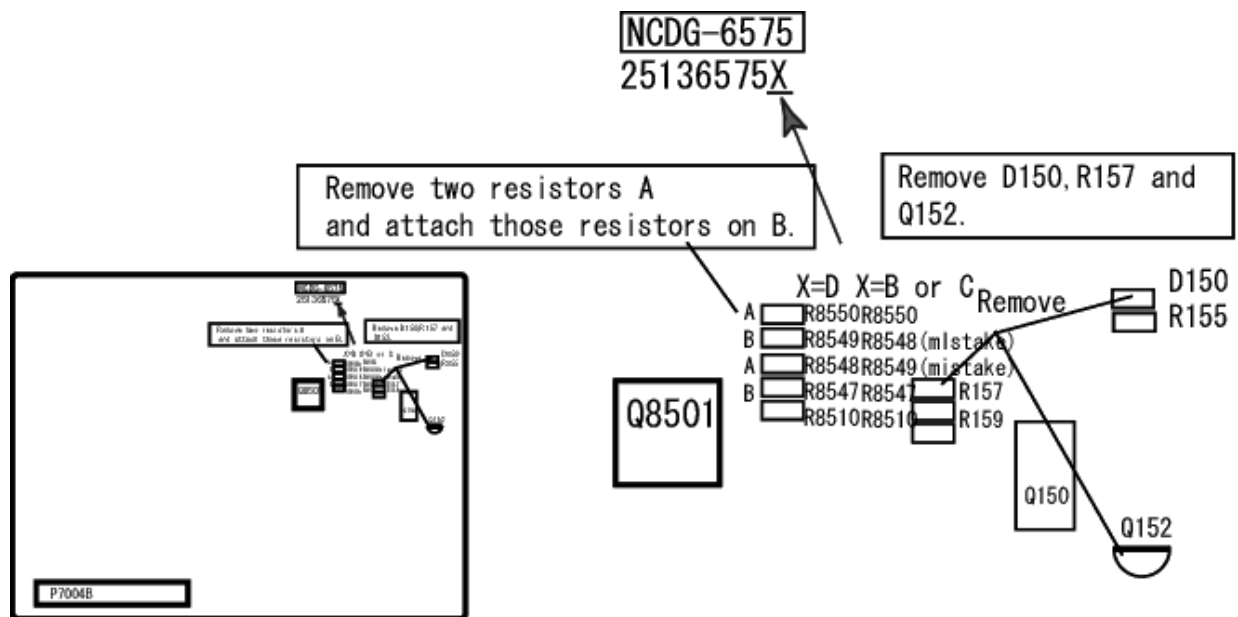
Note: When you change the microprocessor from 045-3BA to 047-3BA, remove 2nd PLL circuit and change the setting of A/D,D/A Converter IC Q8501.

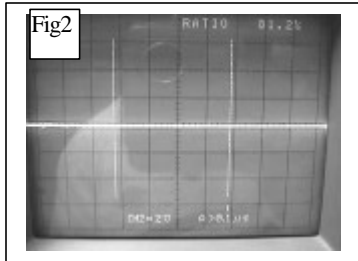
Fig2: Pin 26 and 27 clock is OFF when digital signal is present at pin 12.  
Pin 15 has no signal.

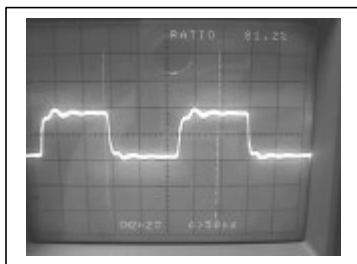
Pin 39 and 41 has no data.

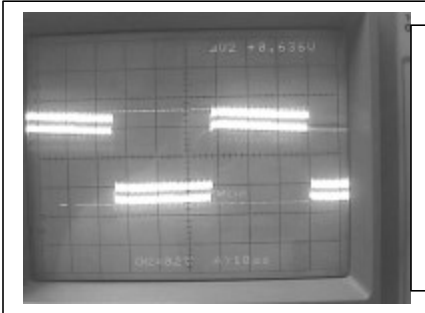
## Pin 29

Pin 41 has a problem as seen. This point is normally 4.5vpp rather than .636vpp. The data appears to be corrupted or very low. If the unit is working properly this point becomes very high and clear data is present. At the same time when the unit appears to work, Q707 temperature runs warmer than when it is not.

At this point a re-check of pin 8 through 17 revealed that some of the data line DC voltages were not as they should be. See chart.

Q710 Defective. Replaced and unit worked.
