# DENON

## Service Bulletin

**Model:** AVR-3311CI, AVR-991

**Subject:** Correction of the Firmware via DPMS (D&M Product Management Server).

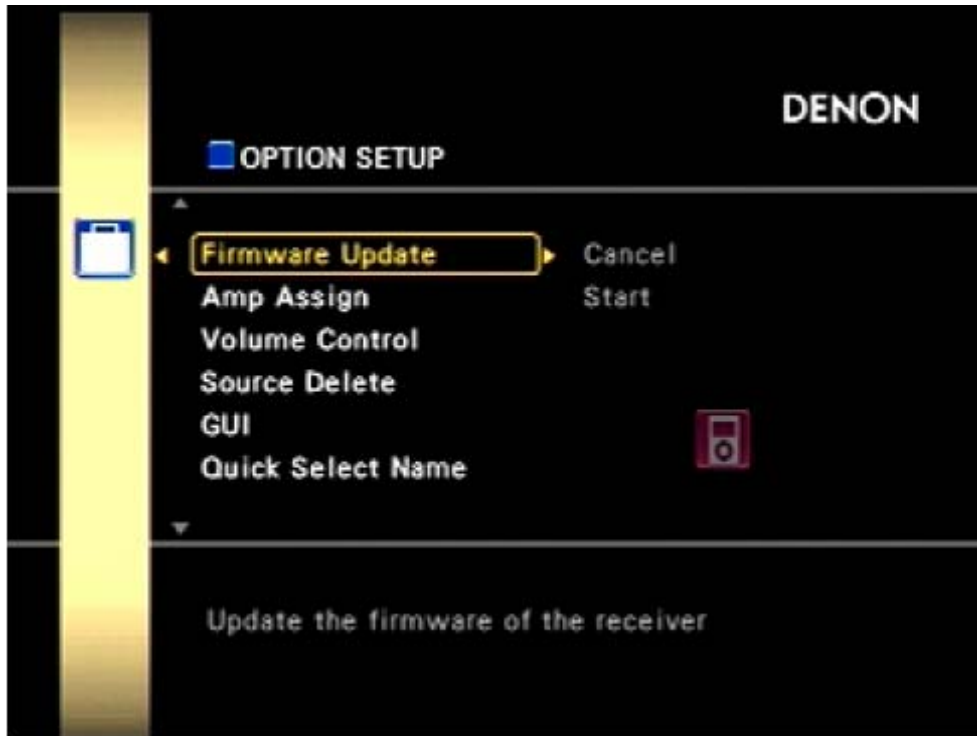
8) The GUI indicates, "**MANUAL SETUP**" > "**OPTION SETUP**" > "**Firmware Update**".

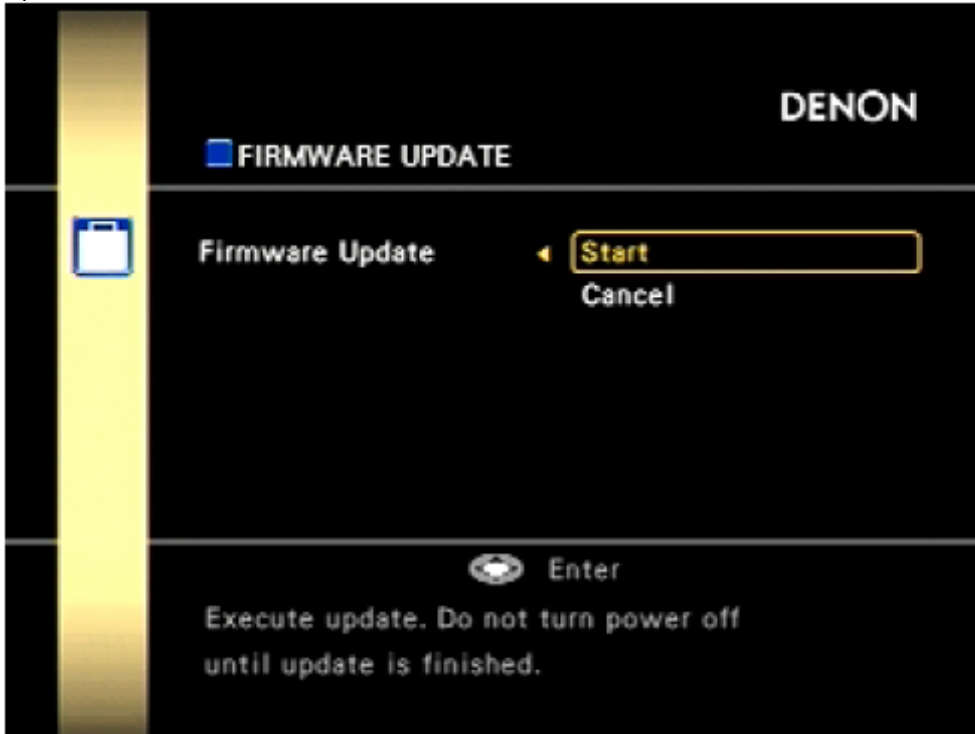
9) Select "Start" on GUI.

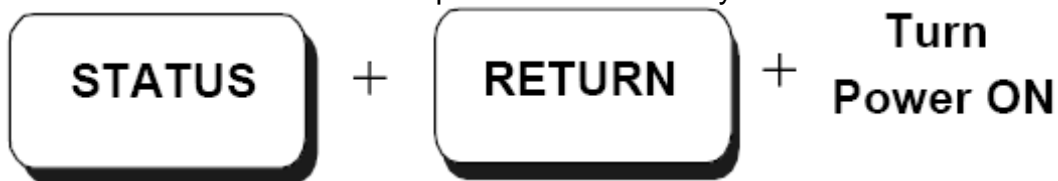
Turn the power of the A/V Receiver on, while holding both "**STATUS**" button and "**RETURN**" button on the front panel simultaneously.

Every time the "**STATUS**" Button is pressed, version numbers of the MAIN, SUB, etc. are indicated on the front panel section in the following order.

After completion of the updating operation, the new version number can be confirmed by starting up the A/V Receiver according to the following procedure. With the following operation, the A/V Receiver can be set to the Flash-ROM Version-Number Confirmation Mode.
