MARCONIPHONE

888

HMV 1105

Four-valve, plus rectifier, three-band superhet, with push-button wave-changing. For 195-255 v., 50-100 cycles.

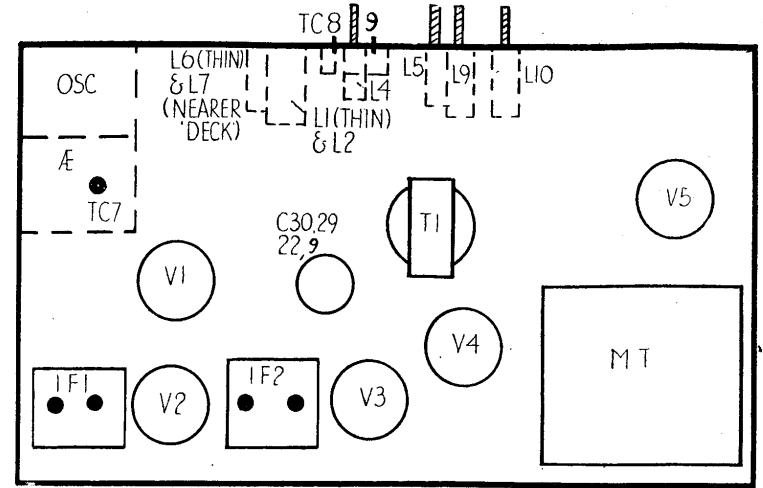
Both trimmer condensers and permeability coils have to be adjusted when aligning this chassis. The set has push buttons for wave switching.

I.F. CIRCUITS.—Adjust at 465 kc. **CALIBRATION.**—See that pointer registers with 192 metres with gang at minimum.

S.W. BAND.—Adjust loops in L7 and L2 at 50 metres.

M.W. BAND.—Adjust TC8 at 192 metres, and TC7 at 220 metres.

Adjust cores of L9 and L4 at 530 metres. Repeat all operations.

L.W. BAND.—Adjust TC9 at 720 metres, L10 at 1,750 metres, and L5 at 1,400 metres. Readjust TC9 at 720 metres.

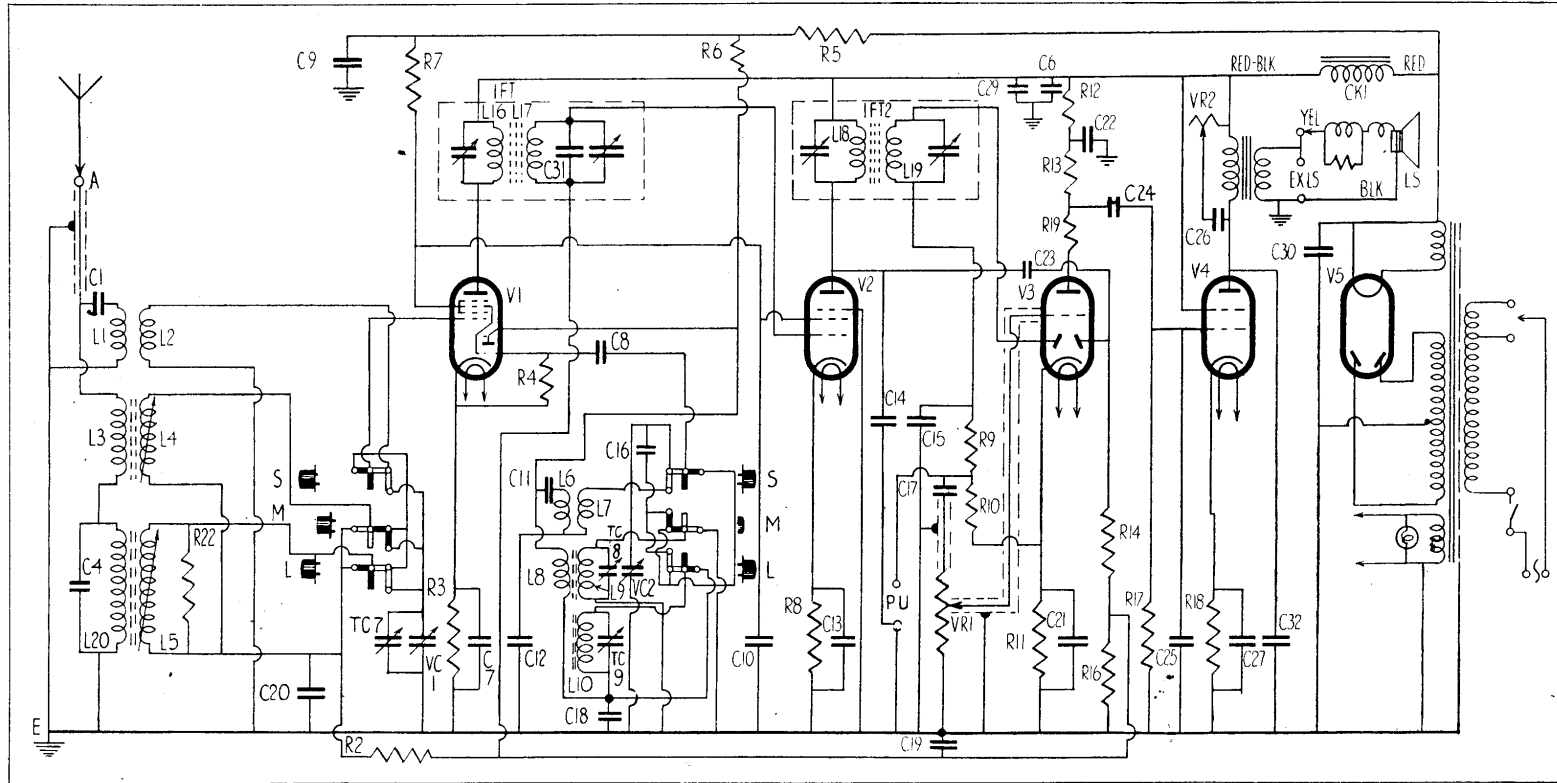
Circuit.—Transformer coils, with iron cores on M. and L.W., lead through push-button wave switches to V1, the frequency changer. Iron-cored I.F. circuits link up V2, the amplifier, and V3, a double-diode triode connected in the usual manner. After the R.C. coupled output valve is a conventional full-wave rectifier, V5.
